HO-368, Boyles Tavern
5760 Main St., Elkridge
Surveyed by: Kristin Hill
March 2003

ADDENDUM

Section 7. Description

Condition: Good, heavily altered

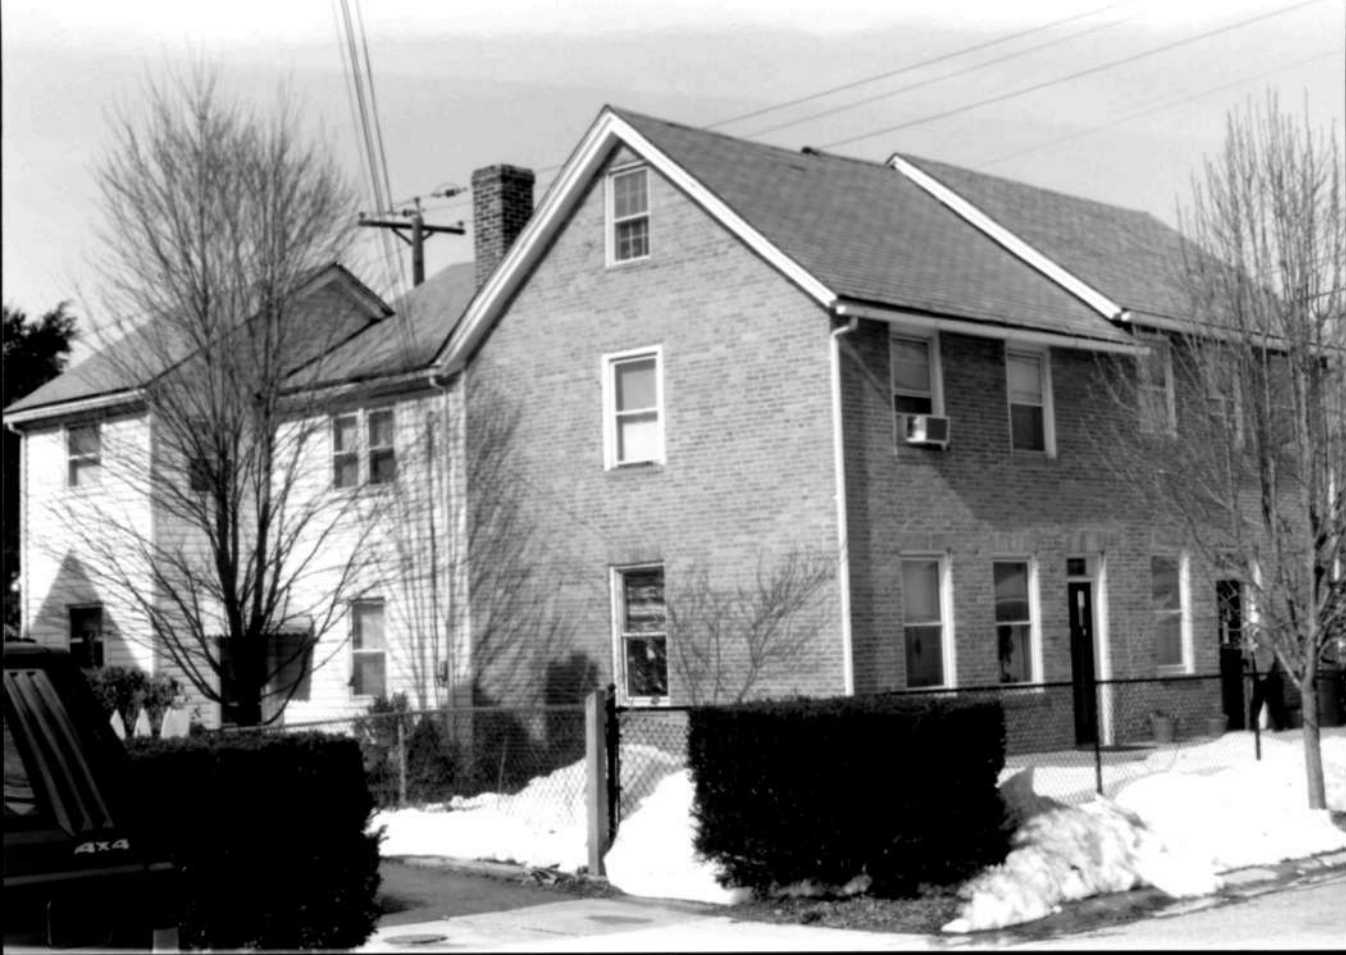
Kristin Hill, 3/03
Negative at MD SHPO
SW elevation
1 of 4

The western façade shows the original building and the third and fourth period frame additions. The original brick building was only one room deep and has one window on each story including one in the gable end. The windows are vertically aligned and the first story window is capped by a gauged flat brick arch. The first and second story windows are 1/1 vinyl replacements. The only possible original window remaining in the building is located in the gable end – it is double hung with 6/6 lights. The window sills on the first and second story have been replaced with modern brick and the window openings have been widened, probably to accommodate the standard sized replacement windows. Brick bond on this façade is 5:1. Two two-story frame additions, now covered with vinyl siding, were made to the rear of the original building.

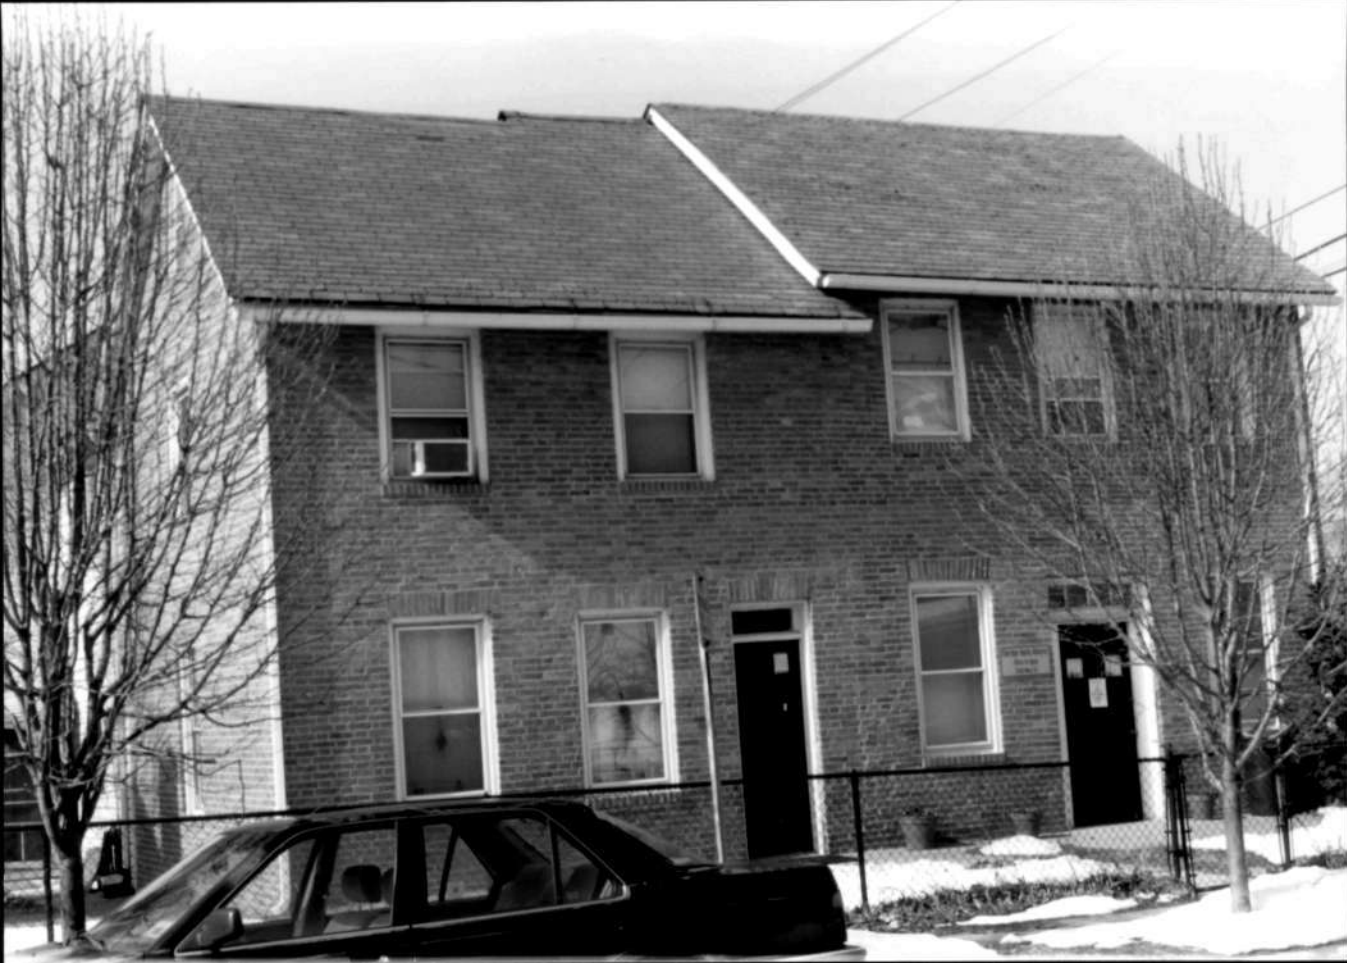
South elevation

The front façade of this building shows both the first and second building periods. The original structure is comprised of the western most two story three bay section which boasts the Flemish bond brickwork. There are two windows in the second story of this section and two windows and a door on the first story. All of the windows are 1/1 vinyl replacements. The second story windows have header brick lintels while the first story windows and door are capped with gauged flat brick arches. All of the original window sills have been replaced with modern brick. The existing door is glazed and paneled with

a transom, and while neither of these elements is original, the opening is an original door opening. The eastern most two story three bay section has 7:1 common bond brickwork on the front façade. Three windows decorate the second story while a central entry flanked by a window on each side completes the first story. All of the windows and the door opening in this portion of the building are capped by gauged flat brick arches, and, as in the original part of the building, the windows are all vinyl replacements and the sills have been replaced with modern brick. The existing door is glazed and paneled with six lights over two vertical panels, and has a four light transom. Again, though neither of these elements is original, the opening is. The existing wooden door frame seems very wide and it is possible that this entry originally had sidelights. The transition between the two sections is marked both by a change in roof height and by inconsistencies in the brickwork from ground to roof. There is no vertical seam; instead care was taken to tie the wall together with Flemish bond, but it is obvious that this is the area of transition from one building phase to another. However, although the two halves have two different rooflines and a noticeable seam, the division between the two sections isn't as clear as you would expect. The Flemish bond actually extends into the wall beneath the later additions roofline one bay. But the line of closers at the point where the Flemish bond terminates (theoretically indicating an opening or a corner) only extends halfway up the second story. There is also an obvious straight seam in the middle of the wall above the door in the later addition that defies explanation. There are no porches or entry porticos. A concrete pad covers an area in front of the building about six feet deep and runs across the full width of the building.

This building has essentially been restored to death. In addition to the multitude of interior alterations, the exterior of the masonry has been sandblasted to remove paint and this has done major damage to the building. The hard exterior surface of the bricks has been blasted away exposing the softer fired bright orange interior to the elements. The bricks are disintegrating rapidly and in some places the brick face has disintegrated to a depth of more than half an inch. The mortar joints were also probably seriously damaged by the sandblasting and the entire building was repointed with a Portland cement based mortar with a distinctive gray cast. This mortar is too hard for the old hand-made bricks and it is causing the faces of the brick to spall off as the bricks shrink and expand with the seasons.

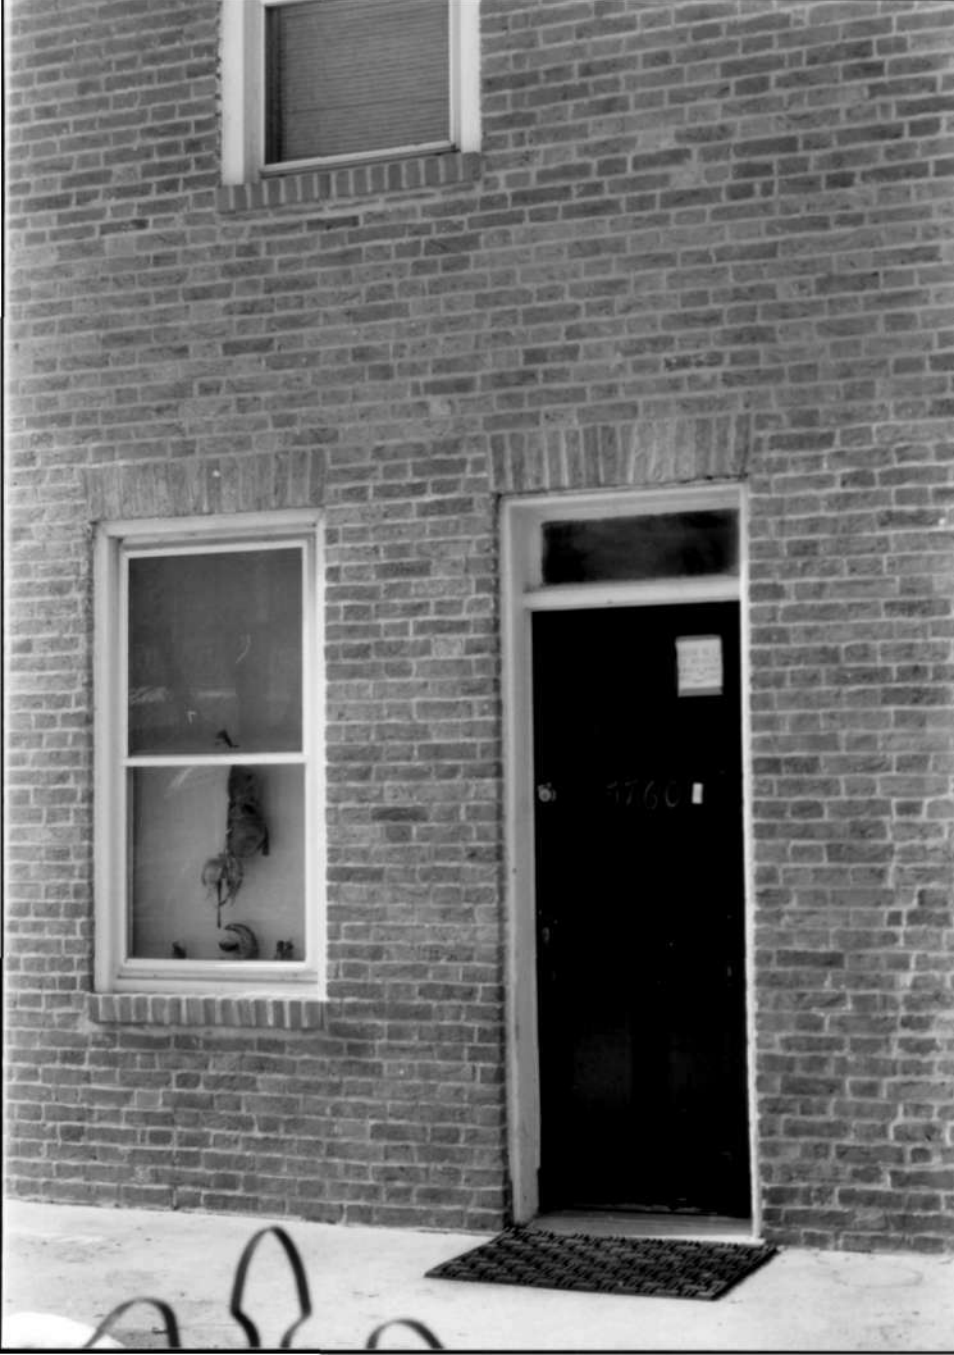
Original entry showing flat arches and replacement
window sill.

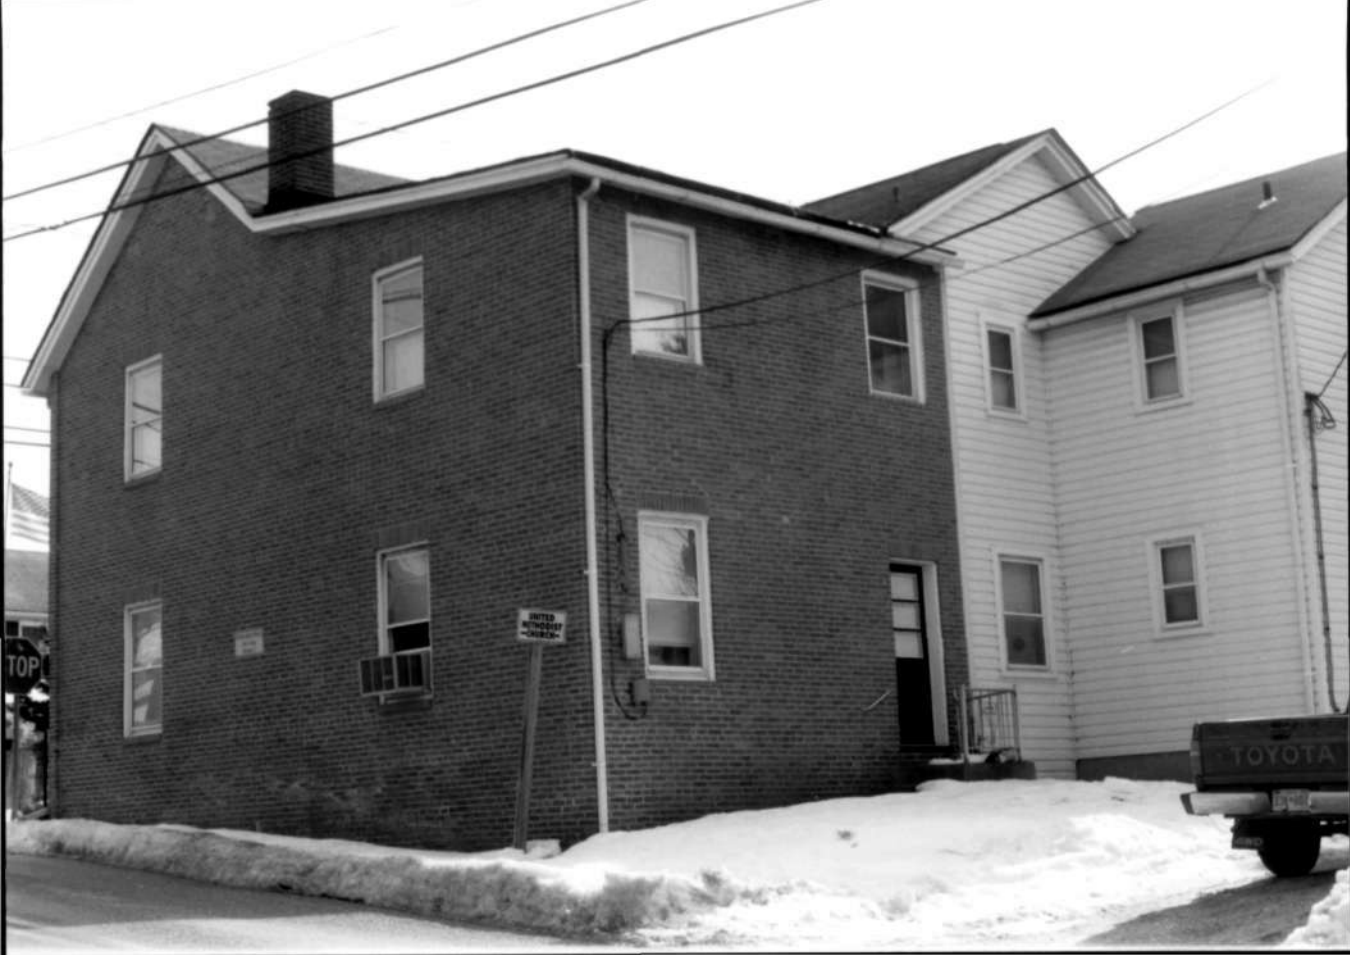
NE elevation

The eastern façade of the building is the eastern façade of the later two story brick addition. This portion of the building is two rooms deep with a side gabled roof over the front room and a shed roof over the rear room. There are two windows in the second story and two in the first. These openings are vertically aligned and capped with flat brick arches. All of the windows are vinyl replacements and the windows sills have been replaced with modern brick. The brick bond on this façade is 7:1. The 1970's inventory form stated that the shed roofed portion of the structure was a later addition but no seam in the brick work is visible to support this claim. There is another anomaly visible on this façade at the front corner of the building: the front façade appears to be a facing. At this corner, the bricks in the front façade extend past the side wall about an inch or two and do not appear to tie into this wall. The idea of a facing or false front doesn't make a lot

of sense, however, when looking at the anomalies and inconsistencies in the front façade. If it was a false front, you would expect a smooth façade with no inconsistencies in the brick bond.
